MNMM Fatal 2006-01

- Falling/Rolling Material
- January 5, 2006 (Arizona)
- Sand & Gravel Operation
- Mechanic
- 39 years old
- 12 years mining experience

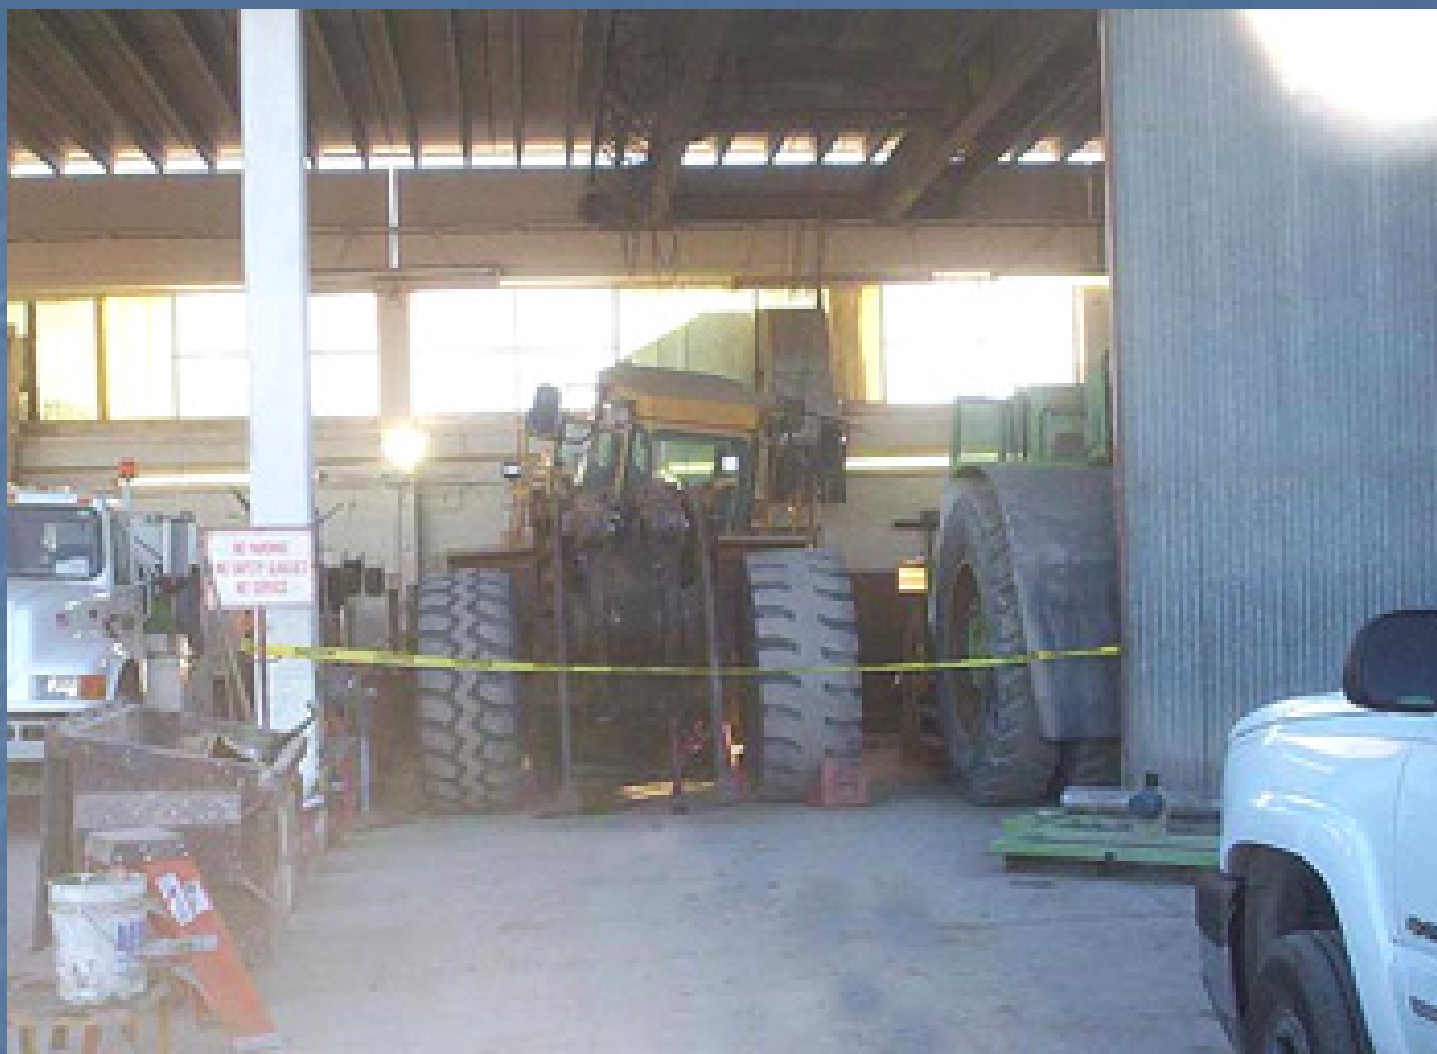
The victim was fatally injured while working on a front-end loader. The front and rear sections of the loader had been separated and each section was independently supported with jack stands. He removed one of the jack stands and was positioned between the left rear tire and fender well/frame to remove a hydraulic hose when the frame of the loader tipped forward on the tires, swiveled to the left on the rear axle oscillation trunnion and crushed him.

- The victim failed to recognize the hazard associated with working on an improperly blocked front-end loader.
- Management failed to use oversight to ensure the job safety analysis procedure to safely block the front-end loader was followed.

- Stop, Look, Analyze, and Manage (SLAM) each task to identify all potential hazards before performing maintenance work. Practice safe work habits during the entire task.
- Consult and follow the manufacturer's recommended safe work procedures for the maintenance task.

- Train miners in safe work procedures before beginning repairs.
- Securely block equipment against all hazardous motion at all times while performing maintenance work. If the equipment being blocked has multiple degrees of movement or freedom, exercise extreme caution because some instability modes may not be obvious.
